Inspection Report

Building Characteristics

Building Style & Type Single family dwelling.

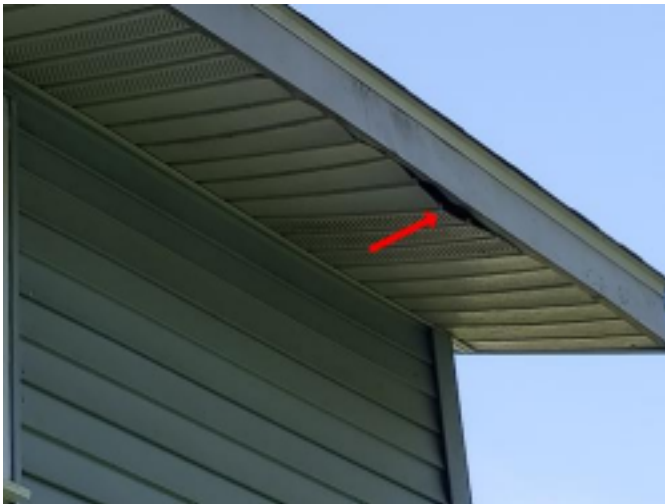
2.4) Eaves-Soffits-Fascias

Nice aluminum soffit and fascia system installed.
Loose soffit noted repairs needed.

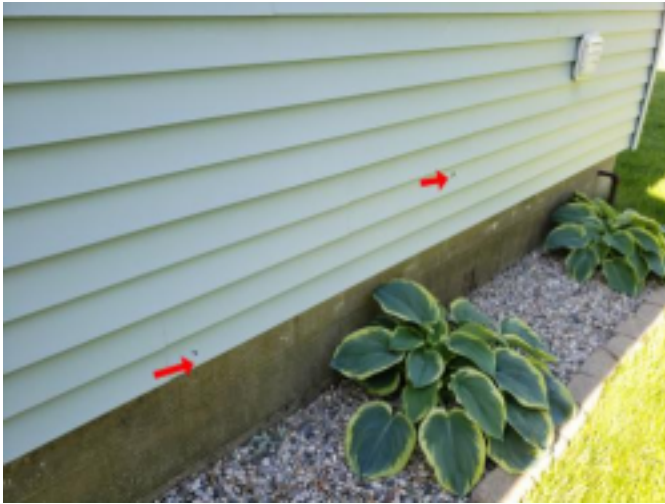
4.1) Condition

Minor damage noted small holes in various areas on siding.

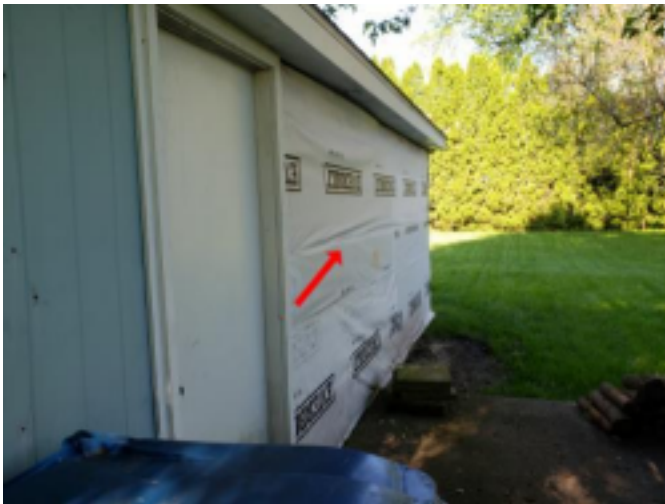
5.6) Type & Condition

General condition appears serviceable.

Recommend completing the installation of siding on exterior side of garage.

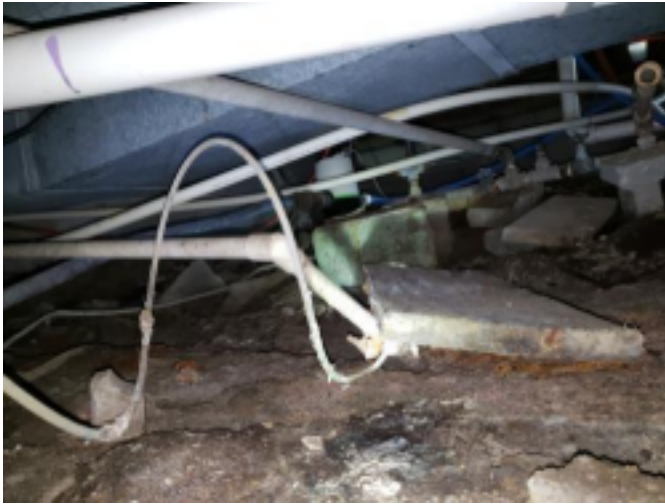
8.2) Main Shut Off Location

Water meter is located in the crawlspace. Main shutoff valve is located next to the meter. Valve is operational. Make sure to show everyone living in the home the location of this valve. This is a good precaution in case of any unexpected water leaks.

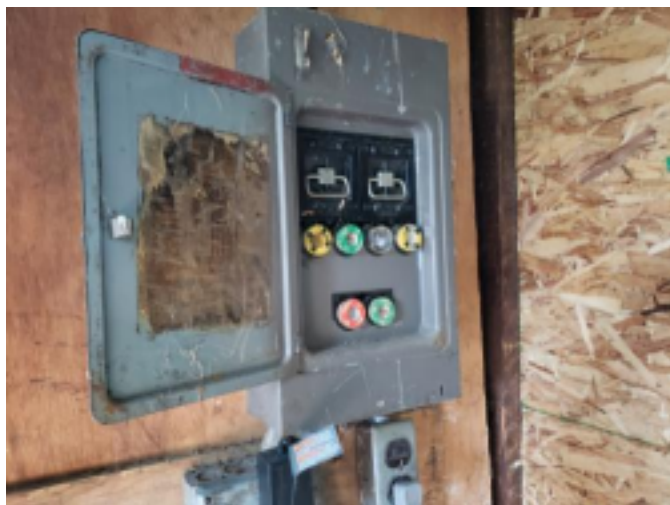
Subpanel Location A sub panel is located at the garage.

The sub panel is in good condition. Wire sizing appears to be correct. The breakers are nicely labeled. Fuses were present at the sub panel.

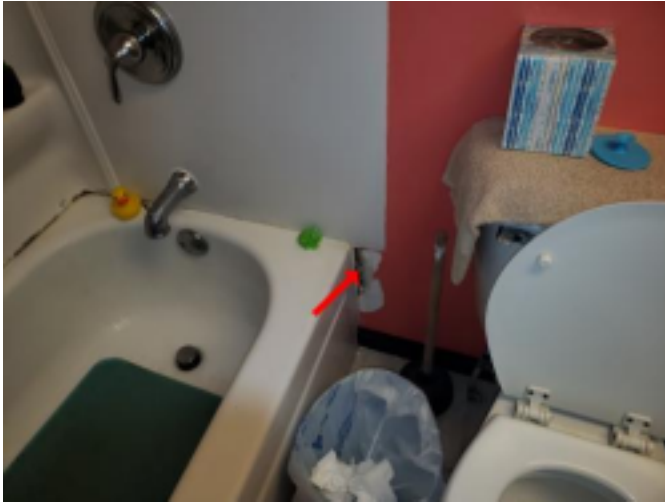
10.3) Shower - Tub Conditions

There was evidence of moisture damage to the wall by the tub in bath . Due to conditions observed, hidden damage may exist in areas not visible or readily accessible. Recommend further evaluation and repair as needed by a qualified / licensed contractor. Please refer to limitations of inspection regarding mold / moisture related conditions. The bathtub, faucet, and drain appeared to be in serviceable condition.

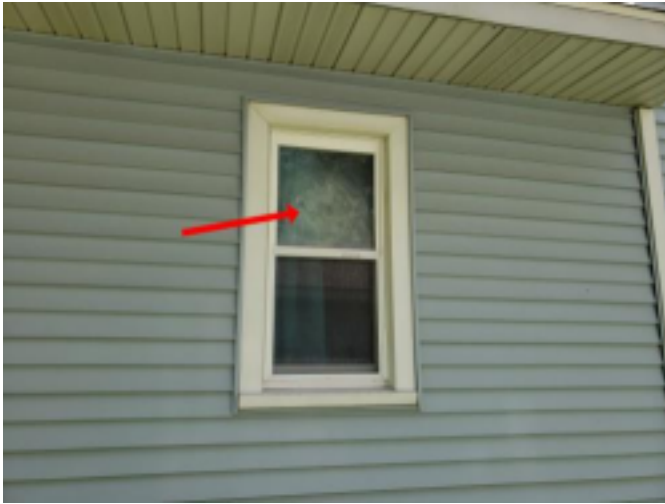
The bathroom thermal pane window lost its thermal seal. Moisture, fogging, and hazing are common signs of this condition. While mostly cosmetic, this condition is generally not repairable. Correction would require replacement of the window or window pane. Company we recommend for window and glass repair is Glass Images 616-928-1033.

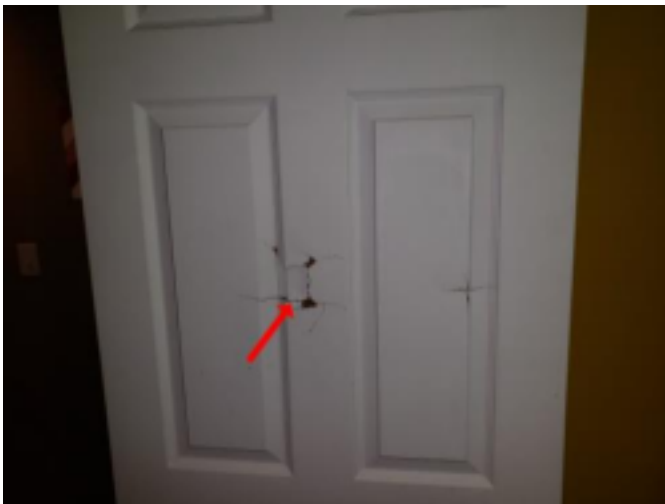
13.5) Interior Door & Trim Conditions

Upstairs bedroom door damage noted. Recommend repair or replacement as needed.
