# Inspection Report

Sound Home Inspections LLC

7/31/2021

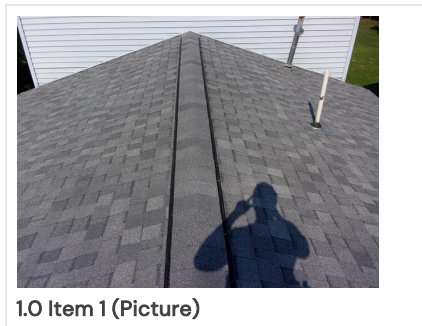
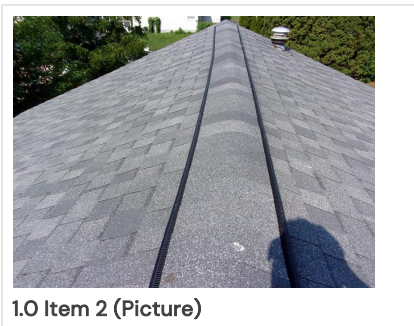
Photos of the roof coverings. No signs of leaks. Item 1 (Picture) Item 2 (Picture)

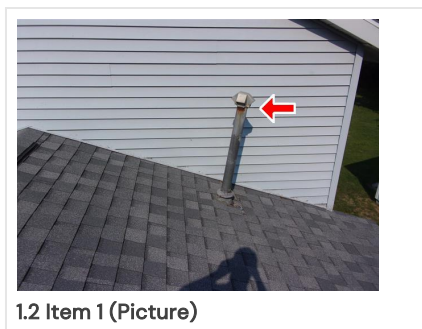
Photo of some type of chimney vent that is not plumb but does not appear to be operational or in use. Consider having contractor evaluate for any concerns. Item 1 (Picture)

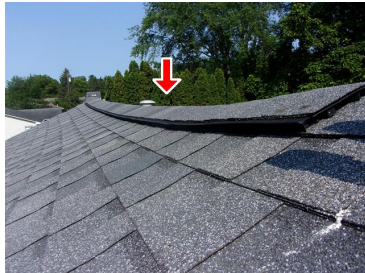
1.5 Item 1 (Picture)

Photo of the roof ridge that is sagging. Consider having roofing contractor evaluate for any concerns and repair/replace if necessary.  
Item 1 (Picture)

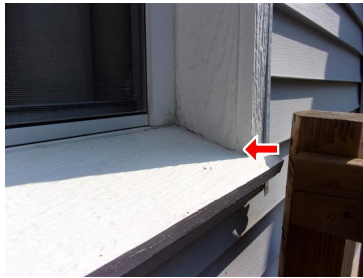
2.0 Item 1 (Picture)

Photos of gaps in siding/trim, damaged siding, and missing siding on the garage. Consider caulking/sealing any gaps, repairing any damaged siding or open holes and having contractor provide estimate for adding missing siding. Item 1 (Picture) Item 2 (Picture) Item 3 (Picture) Item 4 (Picture) Item 5 (Picture)

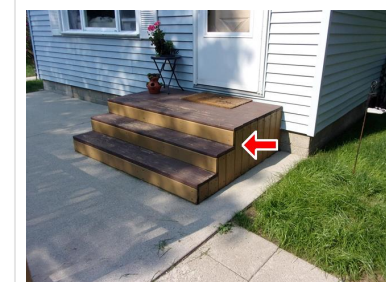
2.3 Item 1 (Picture)

Photo of the front porch that is missing a proper hand rail. Item 1 (Picture)

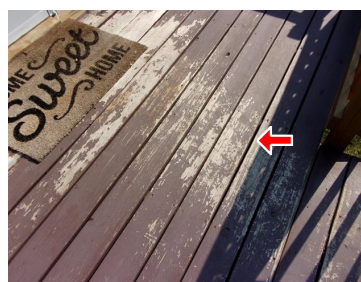
2.3 Item 2 (Picture)

Photo of chipping/peeling paint on the deck. Consider painting/staining any exposed wood on the deck to prevent water penetration and further damage. Item 2 (Picture)

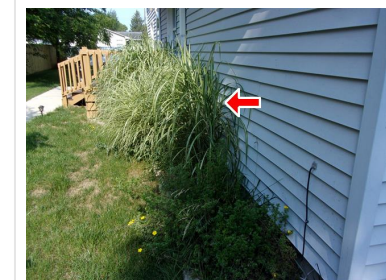
2.4 Item 1 (Picture)

Keep vegetation trimmed away from the house to prevent moisture damage. Item 1 (Picture)

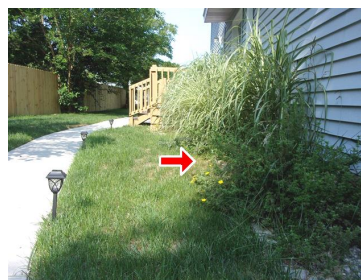
2.4 Item 2 (Picture)

Photo of the grading of the yard that is sloping toward the house. Consider repairing the grading to slope away from the house or adding a french drain to manage water away from the house and to help prevent accumulation of water against the foundation and into the crawlspace. Item 2 (Picture)

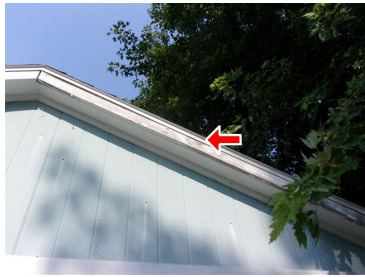
2.5 Item 1 (Picture)

Photos of peeling paint and damaged wood on the fascia and soffit of the garage. Consider painting any exposed wood and repairing any damaged soffit/fascia to prevent water penetration and further damage. Item 1 (Picture) Item 2 (Picture)

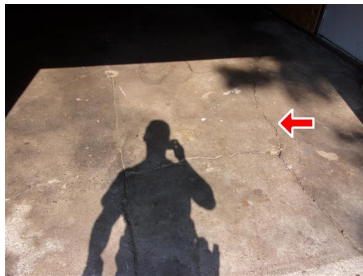
3.2 Item 1 (Picture)

Photo of cracks in the garage floor as evidence of settling. Consider filling any cracks to prevent water penetration and further damage. Item 1 (Picture)

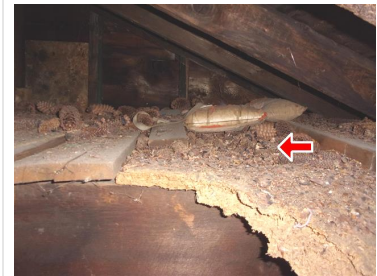
3.2 Item 3 (Picture)

Photo of what appears to be some type of rodent activity above the joists in the garage. Item 3 (Picture)

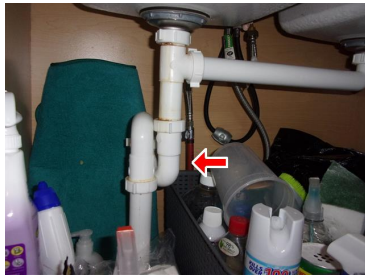
4.6 Item 1 (Picture)

Photo of the kitchen sink drain that has an improper S-trap. Consider having plumbing contractor install a P-trap to prevent sewer gases from entering the home. Item 1 (Picture)

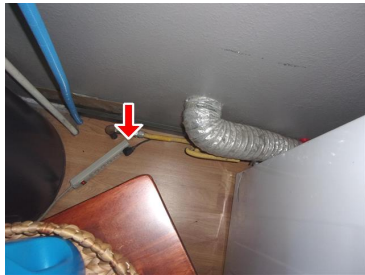
4.8 Item 1 (Picture)

Photo of the dryer that is improperly plugged into a power strip. Have dryer directly connected to outlet to prevent overheating of the power strip. Item 1 (Picture)

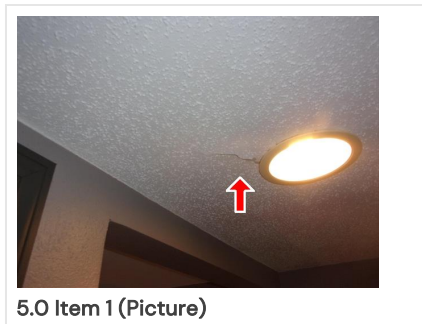
📌 Photo of cracked drywall in the upstairs hall ceiling. Consider patching any cracks. Item 1 (Picture)

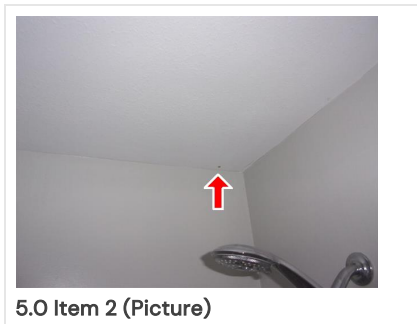
Photo of an exposed/rusted nail/screw in the bathroom ceiling. Consider patching. Item 2 (Picture)

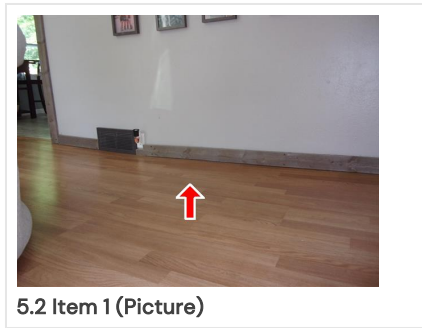
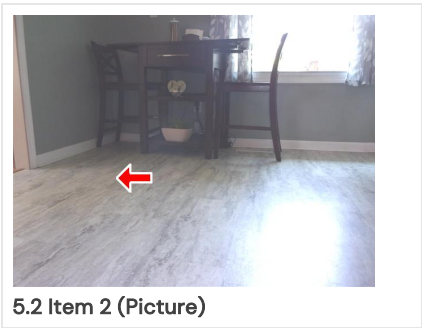
📌 Photos of living room and dining room floors that slope toward the center division as evidence of settling/sagging. See Section 7.3 for more information. Item 1 (Picture) Item 2 (Picture)

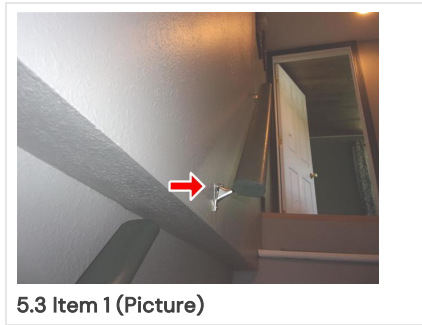
Photo of the upstairs railing mount that has loose screws. Item 1 (Picture)

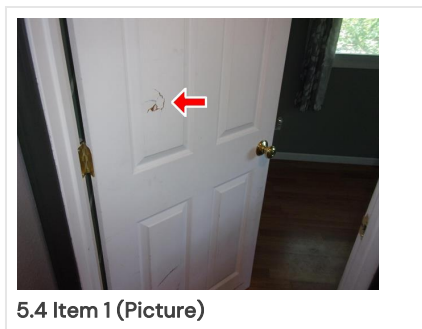
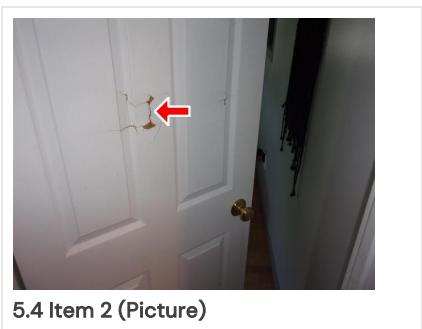
Photos of the upstairs bedroom doors that are damaged. Item 1 (Picture) Item 2 (Picture)

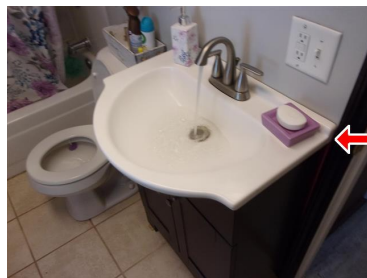
6.0 Item 1 (Picture)

📷 Photo of the bathroom sink/counter that is not secured to the wall/cabinet properly. Item 1 (Picture)

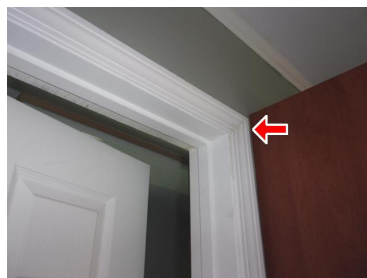
6.1 Item 1 (Picture)

📷 Photo of the bathroom door frame that is loose and door rubs against the top of the frame as possible evidence of shifting of the wall/frame. Consider having contractor evaluate for any concerns and repair/replace as necessary. Item 1 (Picture)

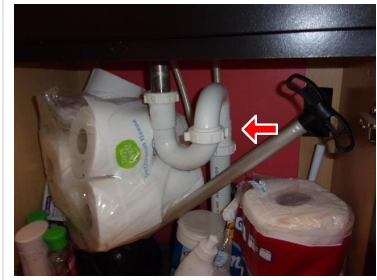
6.3 Item 3 (Picture)

Photo of the bathroom sink drain that has an improper S-trap. Consider having plumbing contractor install a P-trap to prevent sewer gases from entering the home. Item 3 (Picture)

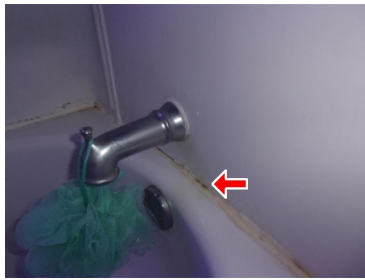
6.3 Item 4 (Picture)

Photo of damaged caulk around the tub. Consider sealing to prevent water penetration. Item 4 (Picture)

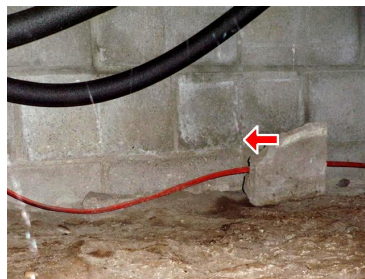
7.0 Item 1 (Picture)

Photos of efflorescence and what appears to be some type of mold/mildew-like substance in the crawlspace as evidence of moisture penetration. Consider cleaning. [Item 1 \(Picture\)](#) [Item 2 \(Picture\)](#) [Item 3 \(Picture\)](#)

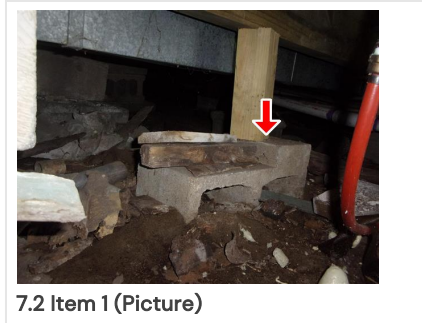
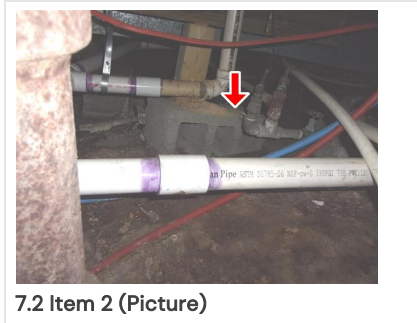
- 🏠 Photos of support blocks that are improperly positioned and sinking into the dirt in the crawlspace below the living room and dining room/kitchen area. Have basement contractor evaluate for any concerns and repair/replace as necessary to ensure the structural integrity of the floor and home above. Item 1 (Picture) Item 2 (Picture)

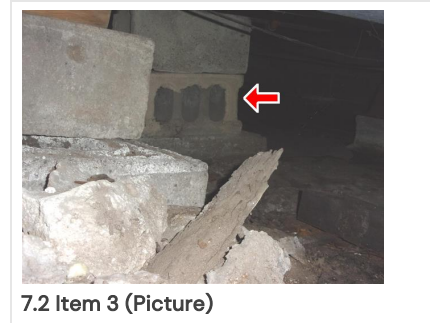
Photo of another support block in the crawlspace that is not properly positioned. Item 3 (Picture)

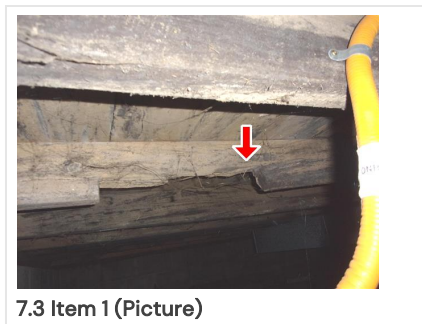
- 🏠 Photo of a floor joist that has been improperly cut. Repair/replace as necessary to ensure the structural integrity of the floor above. Item 1 (Picture)

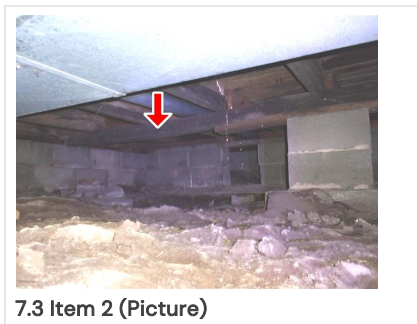
Photo of a support beam in the crawlspace that is sagging. Consider having contractor evaluate for any concerns. Item 2 (Picture)

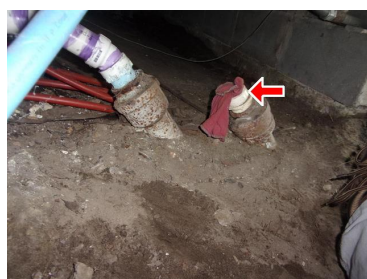
8.0 Item 1 (Picture)

Photo of a waste line in the crawlspace that is not properly capped. Have plumbing contractor properly cap to prevent sewer gases from entering the crawlspace. Item 1 (Picture)

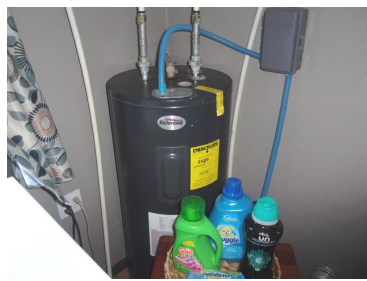
8.2 Item 1 (Picture)

Photo of the electric water heater located in the utility room. Manufactured in 2012. Item 1 (Picture)

The water heater is approaching the manufacturer's recommended life expectancy, budget to be replaced. Item 1 (Picture)

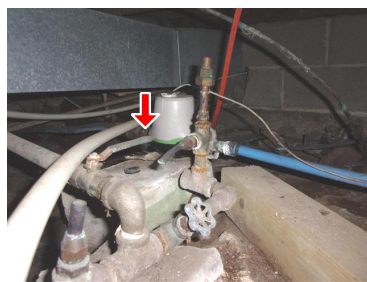
8.3 Item 1 (Picture)

The main water shut-off is located in the crawlspace at the water meter. Arrow points to the shut-off valve. The valve is not in a readily accessible location. Consider having plumbing contractor locate a new valve in case of emergency. Item 1 (Picture)

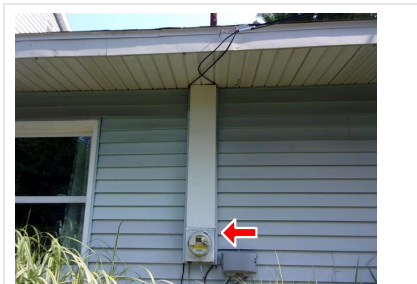
9.0 Item 1 (Picture)

Photo of the overhead electrical service to the house. Item 1 (Picture)

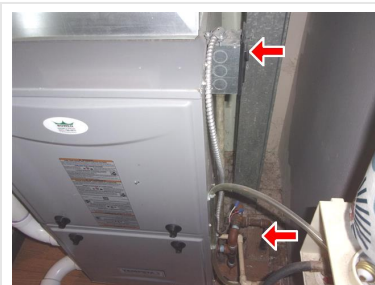
10.0 Item 1 (Picture)

Photo of the furnace in the utility room. Manufactured in 2014. Arrows point to the natural gas shut-off valve and the service disconnect switch. Item 1 (Picture)

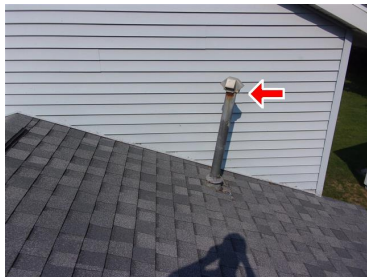
1.2 Item 1 (Picture)

Photo of some type of chimney vent that is not plumb but does not appear to be operational or in use. Consider having contractor evaluate for any concerns. Item 1 (Picture)

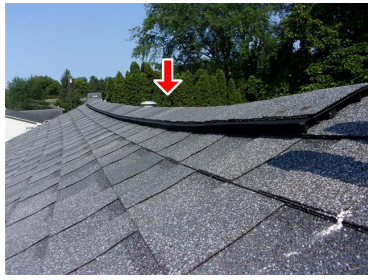
1.5 Item 1 (Picture)

Photo of the roof ridge that is sagging. Consider having roofing contractor evaluate for any concerns and repair/replace if necessary. Item 1 (Picture)

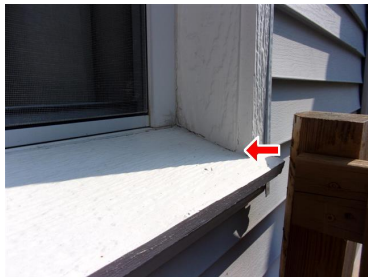
2.0 Item 1 (Picture)

Photos of gaps in siding/trim, damaged siding, and missing siding on the garage. Consider caulking/sealing any gaps, repairing any damaged siding or open holes and having contractor provide estimate for adding missing siding. Item 1 (Picture) Item 2 (Picture) Item 3 (Picture) Item 4 (Picture) Item 5 (Picture)

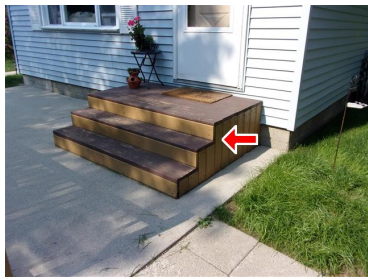
2.3 Item 1 (Picture)

Photo of the front porch that is missing a proper hand rail. Item 1 (Picture)

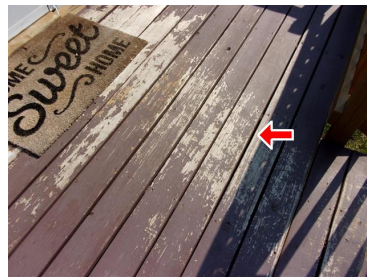
2.3 Item 2 (Picture)

Photo of chipping/peeling paint on the deck. Consider painting/staining any exposed wood on the deck to prevent water penetration and further damage. Item 2 (Picture)

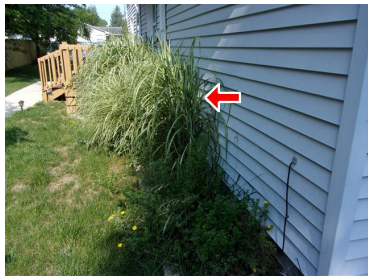
2.4 Item 1 (Picture)

Keep vegetation trimmed away from the house to prevent moisture damage. Item 1 (Picture)

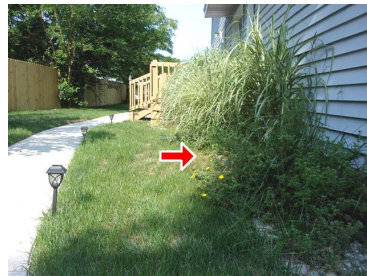
2.4 Item 2 (Picture)

Photo of the grading of the yard that is sloping toward the house. Consider repairing the grading to slope away from the house or adding a french drain to manage water away from the house and to help prevent accumulation of water against the foundation and into the crawlspace. Item 2 (Picture)

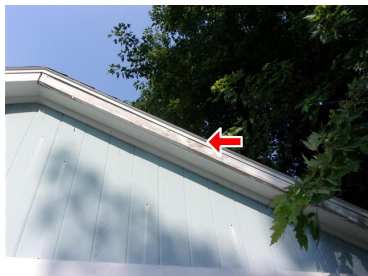
2.5 Item 1 (Picture)

Photos of peeling paint and damaged wood on the fascia and soffit of the garage. Consider painting any exposed wood and repairing any damaged soffit/fascia to prevent water penetration and further damage. Item 1 (Picture) Item 2 (Picture)

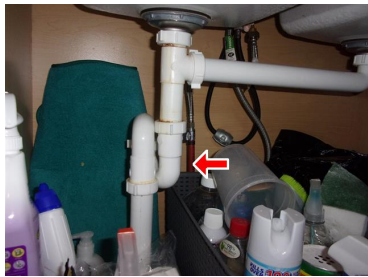
4.6 Item 1 (Picture)

Photo of the kitchen sink drain that has an improper S-trap. Consider having plumbing contractor install a P-trap to prevent sewer gases from entering the home. Item 1 (Picture)

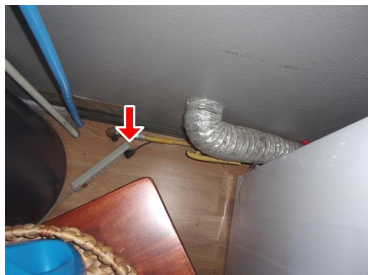
4.8 Item 1 (Picture)

Photo of the dryer that is improperly plugged into a power strip. Have dryer directly connected to outlet to prevent overheating of the power strip. Item 1 (Picture)

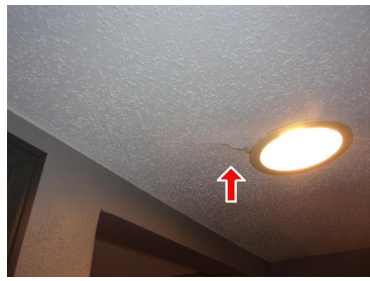
5.0 Item 1 (Picture)

Photo of cracked drywall in the upstairs hall ceiling. Consider patching any cracks. Item 1 (Picture)

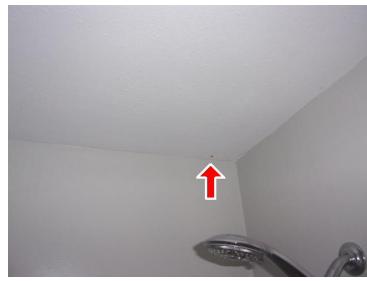
5.0 Item 2 (Picture)

Photo of an exposed/rusted nail/screw in the bathroom ceiling. Consider patching. Item 2 (Picture)

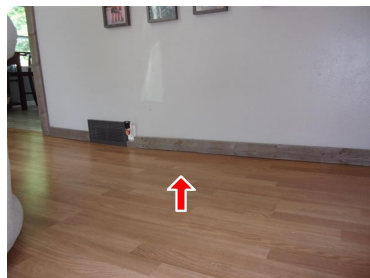
5.2 Item 1 (Picture)

Photos of living room and dining room floors that slope toward the center division as evidence of settling/sagging. See Section 7.3 for more information. Item 1 (Picture) Item 2 (Picture)

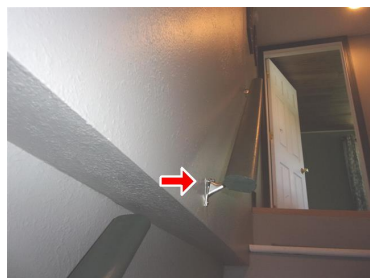
5.3 Item 1 (Picture)

Photo of the upstairs railing mount that has loose screws. Item 1 (Picture)

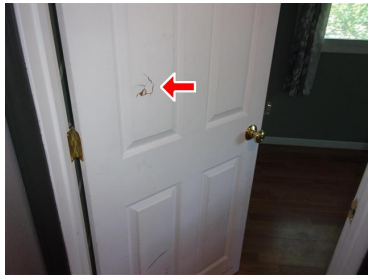
5.4 Item 1 (Picture)

Photos of the upstairs bedroom doors that are damaged. Item 1 (Picture) Item 2 (Picture)

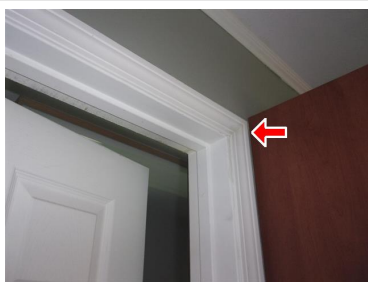
6.1 Item 1 (Picture)

Photo of the bathroom door frame that is loose and door rubs against the top of the frame as possible evidence of shifting of the wall/frame. Consider having contractor evaluate for any concerns and repair/replace as necessary. Item 1 (Picture)

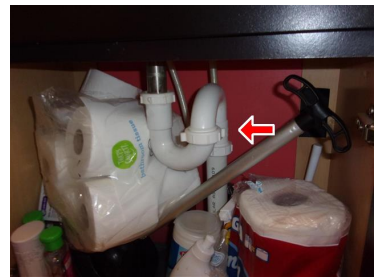
6.3 Item 3 (Picture)

Photo of the bathroom sink drain that has an improper S-trap. Consider having plumbing contractor install a P-trap to prevent sewer gases from entering the home. Item 3 (Picture)

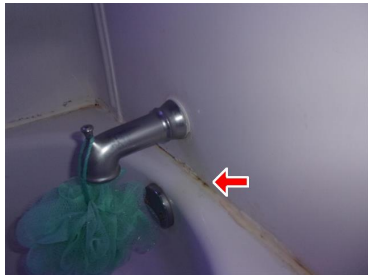
6.3 Item 4 (Picture)

Photo of damaged caulk around the tub. Consider sealing to prevent water penetration. Item 4 (Picture)

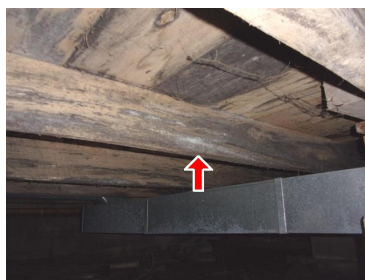
7.0 Item 2 (Picture)

Photos of efflorescence and what appears to be some type of mold/mildew-like substance in the crawlspace as evidence of moisture penetration. Consider cleaning. Item 1 (Picture) Item 2 (Picture) Item 3 (Picture)

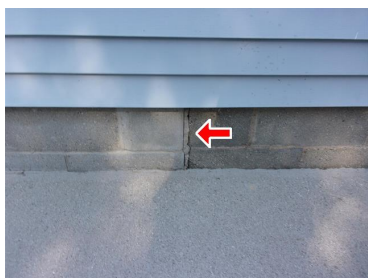
7.0 Item 4 (Picture)

Photos of cracks in the exterior foundation of the house. Consider filling any cracks to prevent water penetration and further damage. Monitor for further movement. Item 4 (Picture) Item 5 (Picture)

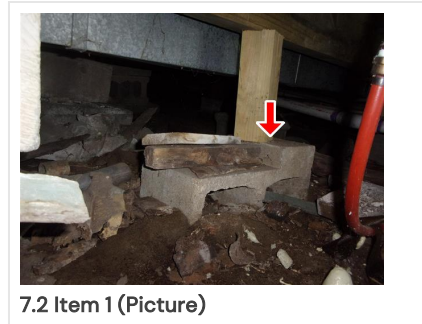
Photos of support blocks that are improperly positioned and sinking into the dirt in the crawlspace below the living room and dining room/kitchen area. Have basement contractor evaluate for any concerns and repair/replace as necessary to ensure the structural integrity of the floor and home above. Item 1 (Picture) Item 2 (Picture)

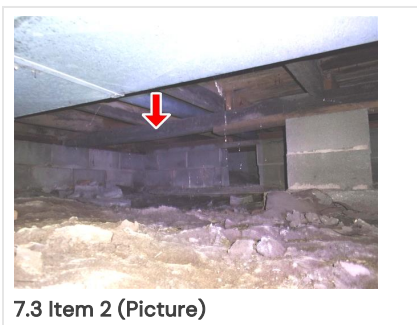
Photo of a floor joist that has been improperly cut. Repair/replace as necessary to ensure the structural integrity of the floor above. Item 1 (Picture)

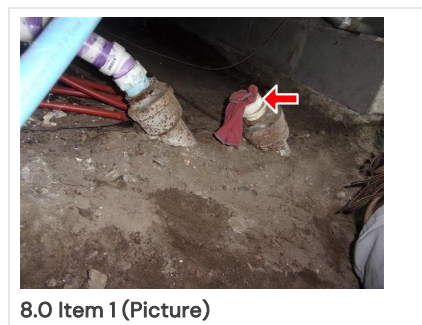
Photo of a waste line in the crawlspace that is not properly capped. Have plumbing contractor properly cap to prevent sewer gases from entering the crawlspace. Item 1 (Picture)

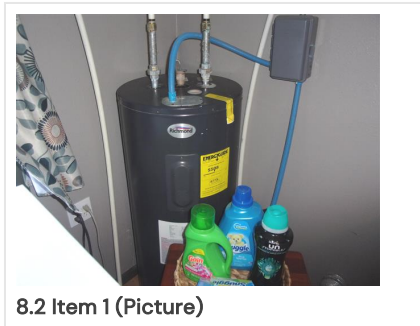
Photo of the electric water heater located in the utility room. Manufactured in 2012. Item 1 (Picture)

The water heater is approaching the manufacturer's recommended life expectancy, budget to be replaced. Item 1 (Picture)

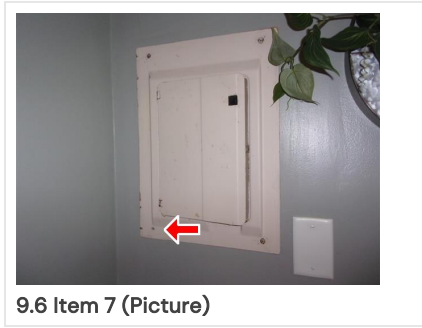
9.6 Item 7 (Picture)

Photo of the main panel in the house that is missing a cover screw. Item 7 (Picture)

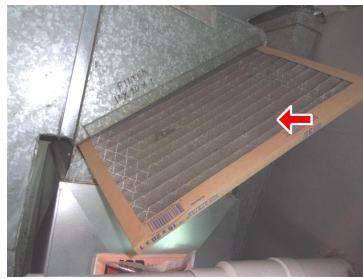
10.3 Item 2 (Picture)

Photo of the furnace filter that is dirty and should be replaced before use. Check furnace filter monthly and replace as necessary. Item 2 (Picture)
